## Lessons learnt from the Deluge of Kedarnath, Uttarakhand, India

Piyooch Rautela

*Disaster Mitigation and Management Centre, Department of Disaster Management, Uttarakhand Secretariat,  
Dehradun – 248 001 Uttarakhand, India. E-mail: rautelapiyoosh@gmail.com*

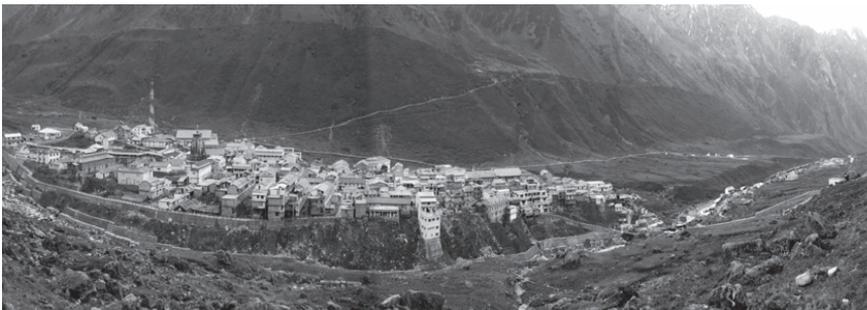
Figure 1 View of the temple township of Kedarnath, with camera looking east.

of 3581 meters above sea level (asl). The shrine of Kedarnath is located on raised middle portion of the deposit that is 20 – 25 meters above the level of Mandakini (3562 meters asl). For reaching Kedarnath(Fig. 1) one had to trek upstream along the course of Mandakini from Gaurikund for a distance of 14 kilometers.

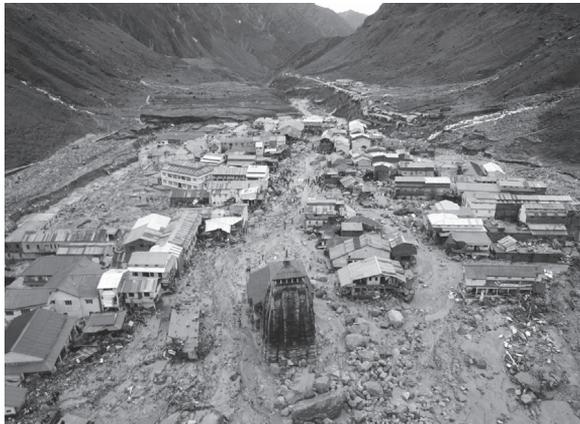
Figure 3 View of the Kedarnath township ravaged by the flood of June, 2013 with camera looking south.

Continuous rains caused the level of water in Chorabari Tal to rise. With the recession of the glacier the lake had a weak moraine barrier that could not withstand continuously rising hydrostatic pressure. Stage was thus set for a major disaster in Kedarnath and the barrier gave way around 0700 hrs on 17 June 2013. The volume of water was enormous and it carried with it huge glacial boulders and outwash material that choked the western channel of Mandakini and the flow of

water and debris got diverted towards Kedarnath township that was thus ravaged (Fig. 3). There was absolutely no warning and most people were taken by surprise and had no time to respond. Besides Kedarnath this event caused devastation in Rambara, Gaurikund, Sonprayag and other places.
